**הנדון: דוח ממצאי סקר קרקע, מתחם תכנית תמ"ל 1002, תל השומר צפון**

## דוח ממצאים, סקר קרקע תמ"ל 1002, תל השומר

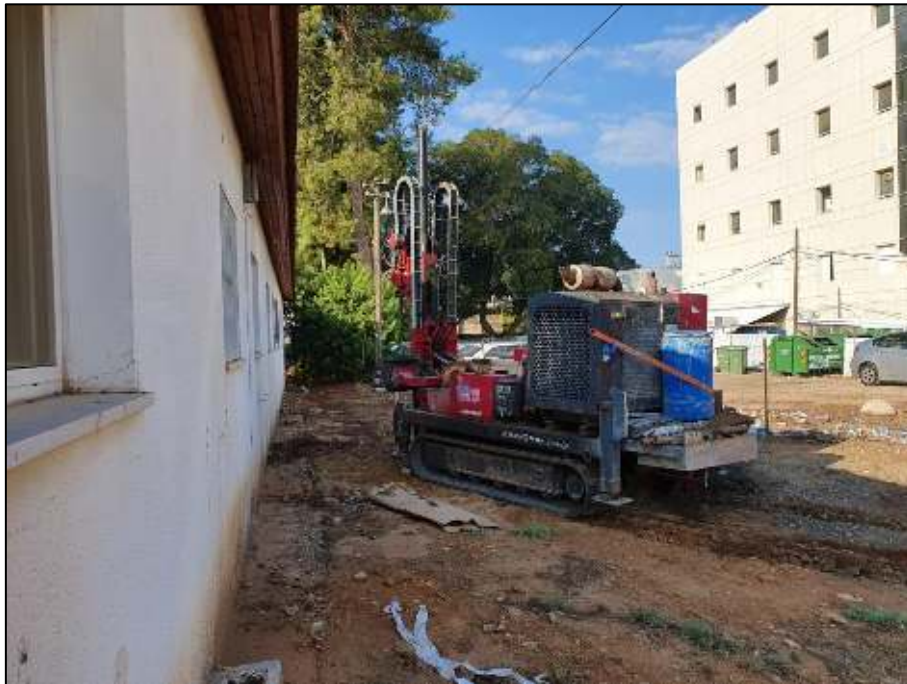
### תמונה 1 – קידוח ג-21

| PID | לחות | תיאור חתך קרקע | עומק (מ') | דוגמה | קידוח |
|---|---|---|---|---|---|
| 19.6 | יבש | חול חרסיתי אדום | 1.0 | A-1 | ג-21 |

**ממצאי שדה – בכל הקידוחים לא נמצאו ממצאים חריגים בשטח ולא נמדדו קריאות משמעותיות במכשיר ה PID, פרט לדוגמה מעומק 1 מ' בקידוח ג-21 בה נמדד ריכוז מעט גבוה של 19.6 ppm.**

בהתאם לממצאי החקירה עד כה בחלק א' בלבד, מומלץ כי המבנים המתוכננים בחלק א' במיקום הקידוחים בהם נמצא זיהום בגזי קרקע ימוגנו מפני חדירת גזי קרקע בהתאם להנחיות המעודכנות של המשרד להגנת הסביבה.
